Case Study: Grounding of the MONCHEGORSK, Bridge Team Management, and Passage Planning.

First presented at the Marine Casualty Symposium (MarCas) 2000,
Linthicum Heights, Maryland, USA

Case Study: Grounding of the MONCHEGORSK, September 5, 1998

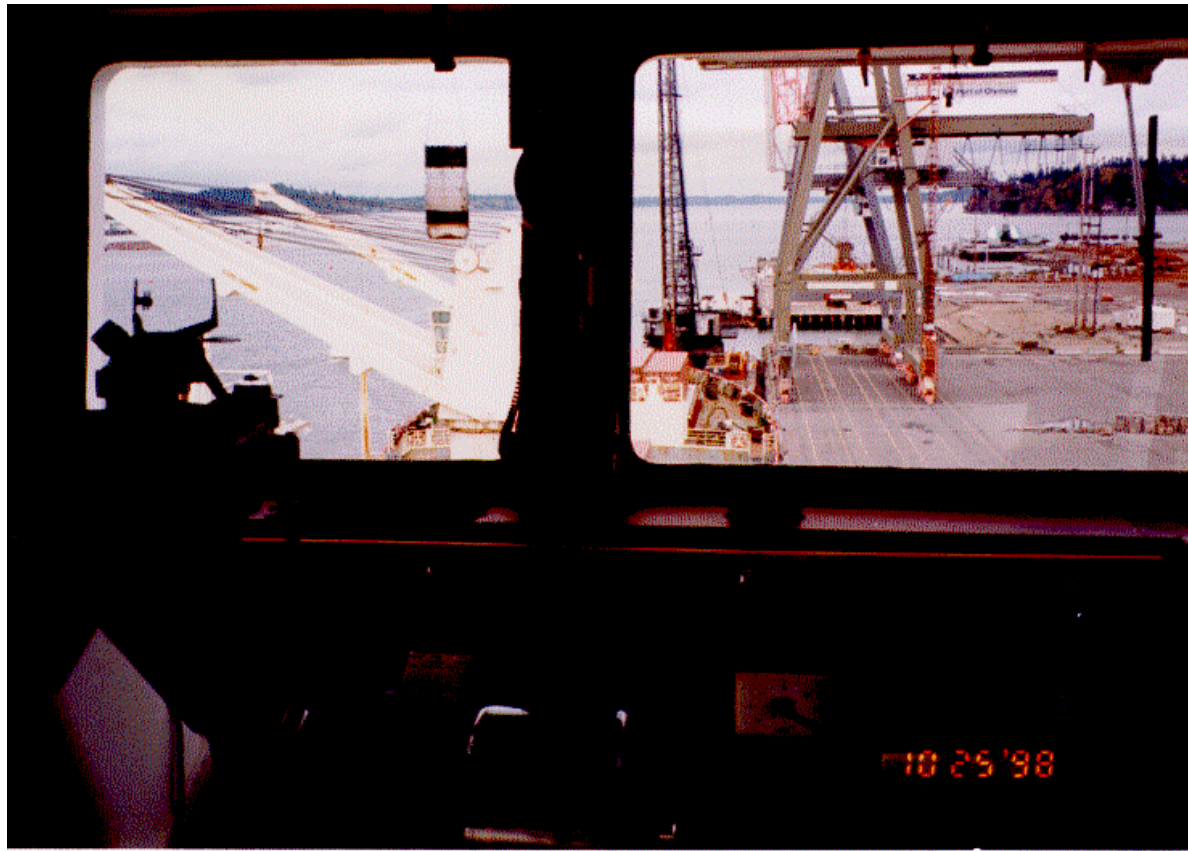
View looking forward from MONCHEGORSK's bridge at the starboard control station. Picture taken when MONCHEGORSK returned to Olympia, Washington about a month and a half after the grounding.

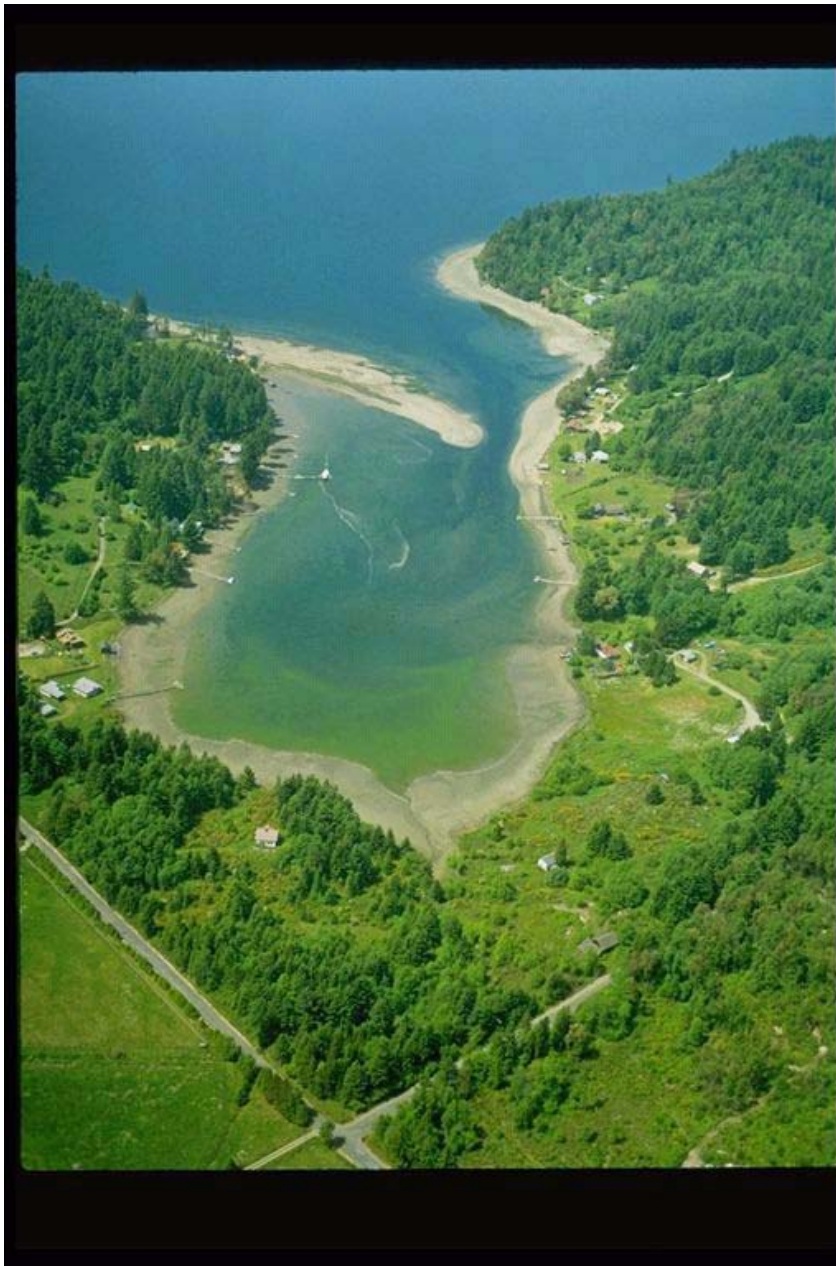
Grounding Location:
Amsterdam Bay, Anderson
Island, Washington. Aerial
photo taken in 1992 looking
from head of Amsterdam
Bay to the west. Note the
sand spit across the entrance
to the bay.

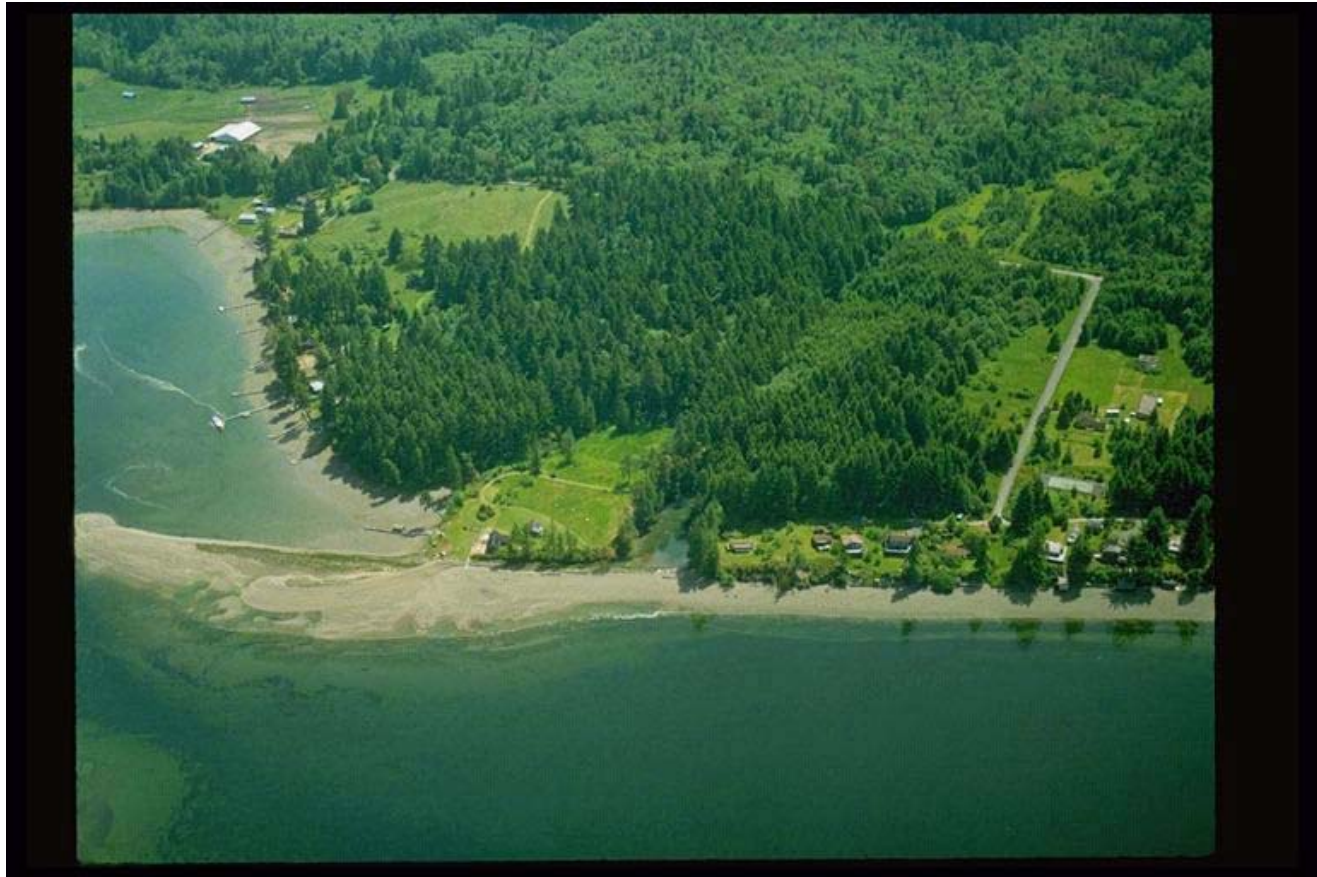
Grounding Location: Aerial photo looking east towards Anderson Island, just south of the entrance to Amsterdam Bay. Photos of the MONCHEGORSK approaching the bay prior to grounding were taken from the group of homes to the lower right of the picture.

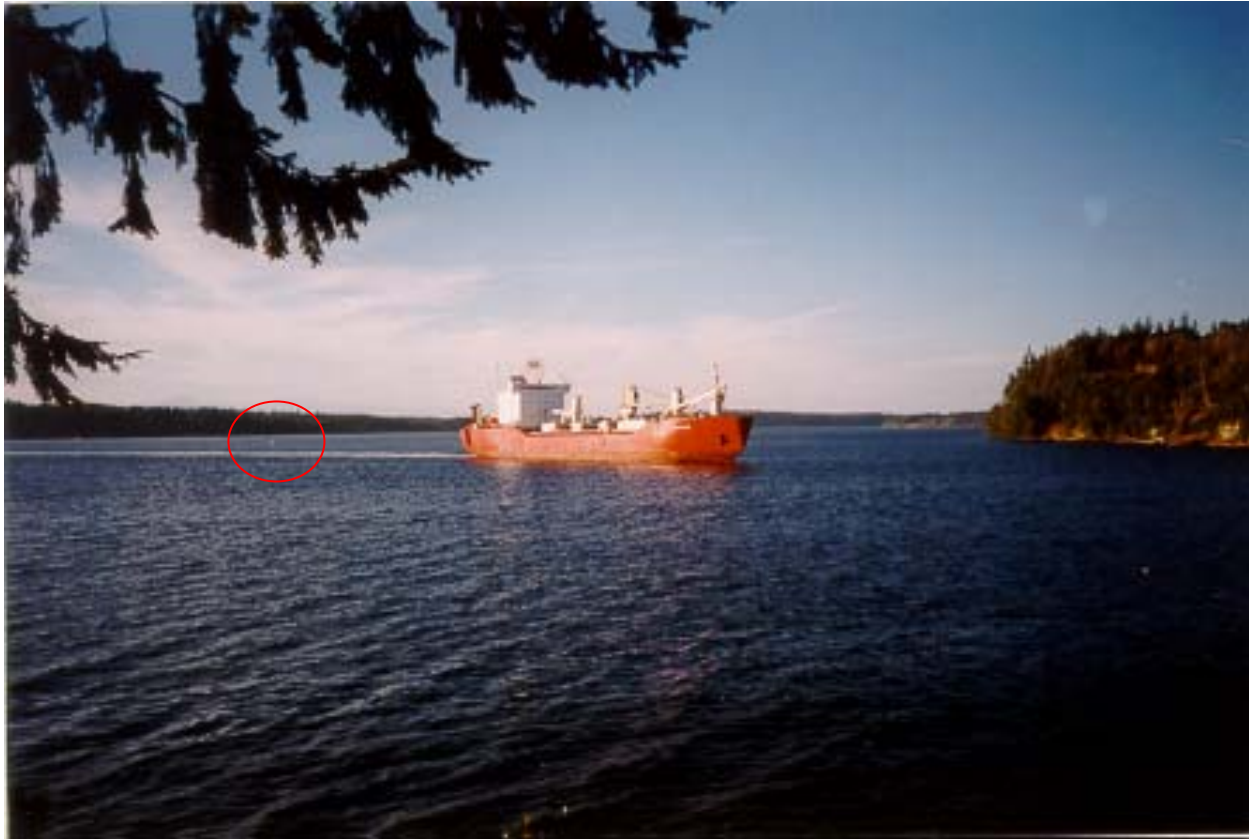
MONCHEGORSK approaching Amsterdam Bay on September 5, 1998. View is from homeowner's property south of the Bay entrance looking approximately north. Small power boat can be discerned behind the ship (circled). Aboard that boat was one of the witnesses to the grounding. Note the point north of Amsterdam Bay entrance in the right of the photo.

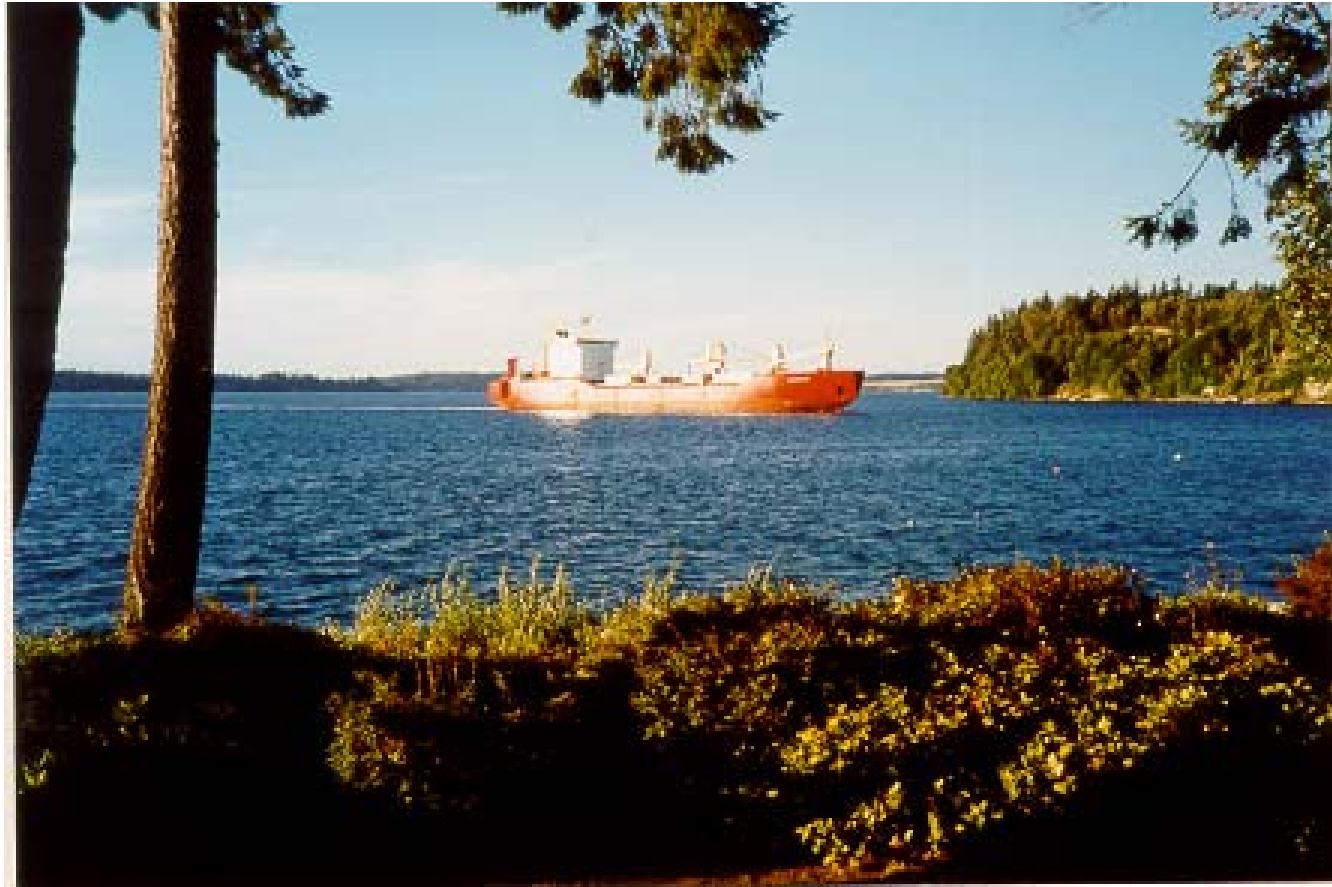
MONCHEGORSK approaching Amsterdam Bay on September 5, 1998.
View is from homeowner's property south of the Bay entrance looking
approximately north.

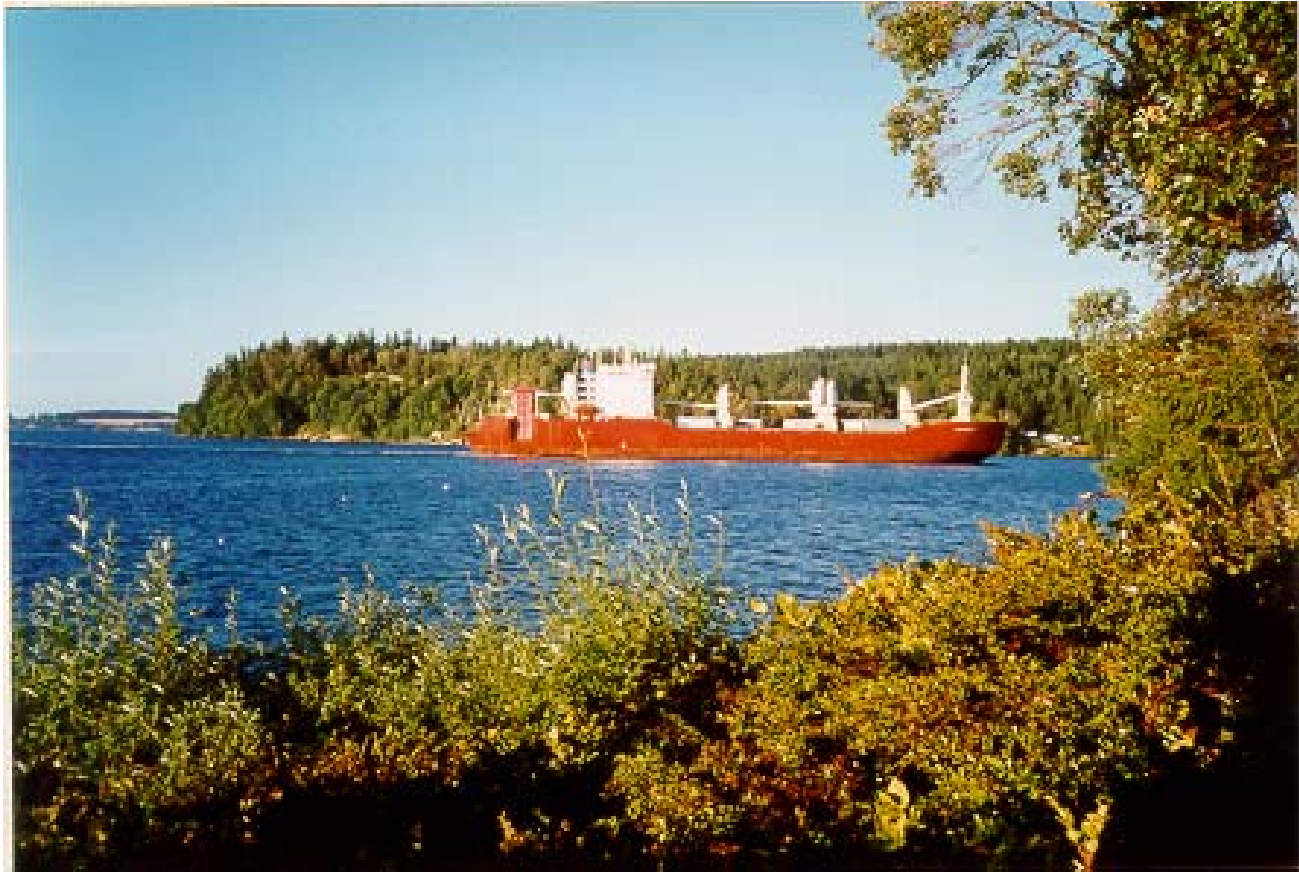
MONCHEGORSK entering Amsterdam Bay on September 5, 1998.
View is from homeowner's property south of the Bay entrance looking
approximately north.
